Technical Bulletin

No: TDL-0047-B
Page 1 of 1

Issue Water overflow on top load washer.

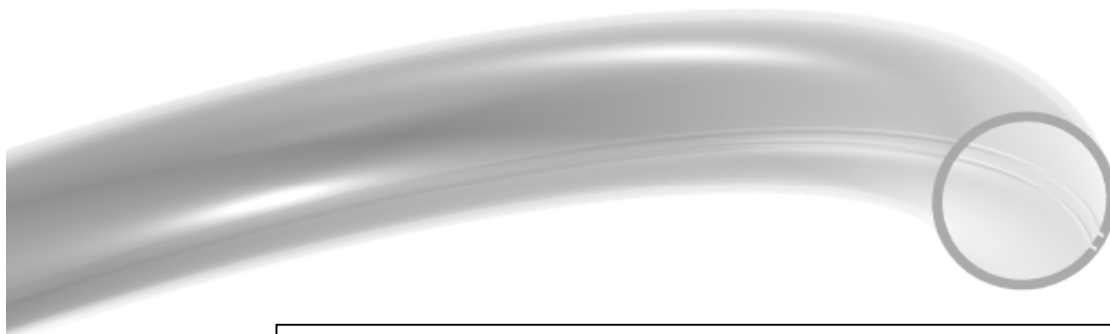
A **limited** number of models produced in May, June, and July of 2003 with "CN" at the end of the serial number could have an Air Dome Hose imperfection.

Extrusion Marks occurring on a small number of Air Dome Hoses.

Action **On a small number of models listed above** if the Water Valve and Pressure Switch are not at fault, inspect the Air Dome Hose for extrusion marks on the inside diameter of the hose. During a water fill the extrusion marks could allow the air to bleed out of the hose causing water to overflow. Replace the Air Dome Hose after confirming the extrusion marks are present. It is not necessary to replace the Water Valve or Pressure Switch if it's determined the Air Dome Hose is at fault.
