Technical Bulletin

No: TDL-0139-B
Page 1 of 1

Product
Laundry

Issue Noisy brake squeal during last few seconds of "spin -down" prior to stopping.

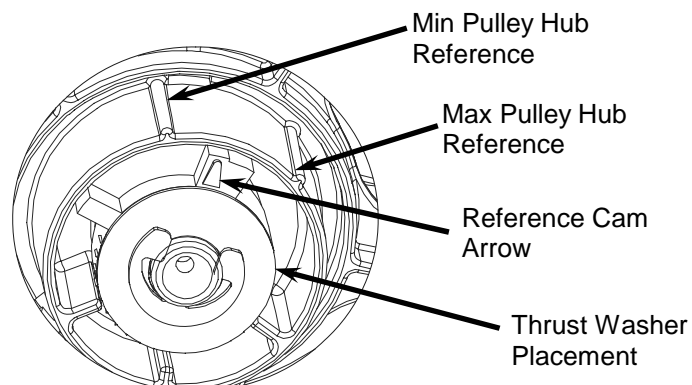
This was an issue with some washers built in early 2005, where the brakes were not installed correctly. The transmission(s) were improperly shimmed allowing the inner tub to rotate slightly during agitation. The result was a little slippage of the rotor on the stator, creating a glazed surface on the rotor. This glazed surface of the rotor made the noise when it rubbed against the stator. The problem can cause the brake to "chirp" intermittently because the brake rotor is not making full contact with the stator while the machine is in agitation.

1. Manually rotate the drive pulley in a slow counterclockwise direction until the brake starts to release and the transmission begins to turn.
2. The position the "Reference Cam Arrow" should be midway between the "Min Pulley Hub Reference" and the "Max Pulley Hub Reference" markers located on the Pulley. If the position of the Cam Arrow to the Pulley Hub ***is not*** within these parameters ***adjustment is required***.

1. If the position of the Cam Reference Arrow is ***less than the Min Pulley Hub reference mark***, remove the standard (.062 thickness) thrust washer and replace it with a thinner (.032 thickness) thrust washer. Recheck disengagement 3 times to verify proper adjustment.
2. If the position of the Cam Reference Arrow is ***more than the Max Pulley Hub reference mark***, add a (.032 thickness) Thrust Washer to the standard Thrust Washer. Recheck disengagement 3 times to verify proper adjustment.
